MEDICAL OFFICERS OF HEALTH, in the ordinary course of their daily duties, not unfrequently meet with examples of plumbing and drainage work which are ill-planned, or ill-executed, or both. Early in 1885 it occurred to me that if all such instances of bad work were briefly noted when observed, and a record kept of them, they would furnish interesting material for a column in some current publication, lay or professional. I accordingly printed a note in the *Health Journal*, a small monthly periodical till lately published by Mr. Heywood, inviting medical officers of health and inspectors discovering any defect in domestic sanitary fittings, drainage, or water service to write a description of the same, and send it, with a rough diagram, to me. My invitation was responded to, and thus, with instances of bad work communicated to me, and examples noted in my own district, I was generally able to find material enough to fill my column of "defects." In this manner ninety-one defects were described and illustrated in the pages of the *Health Journal*, many of my notes and illustrations being subsequently reproduced in other periodicals. These ninety-one examples of defective work, togethe

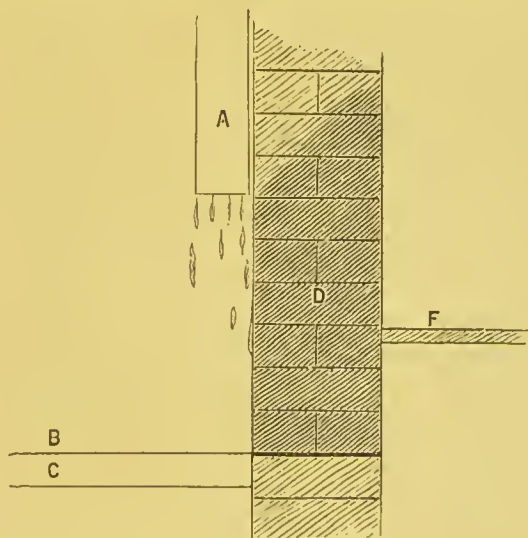
FIG. 1.

Figs. 1 and 2 illustrate the negligent way in which rain spouts are fixed, and the resulting nuisance from damp. The examples are taken from two new houses in a new street.

Fig. 1 shows the rain spout terminating 18in. above the surface of the pavement, and consequently discharging large quantities of rain directly on the wall of the front parlour.

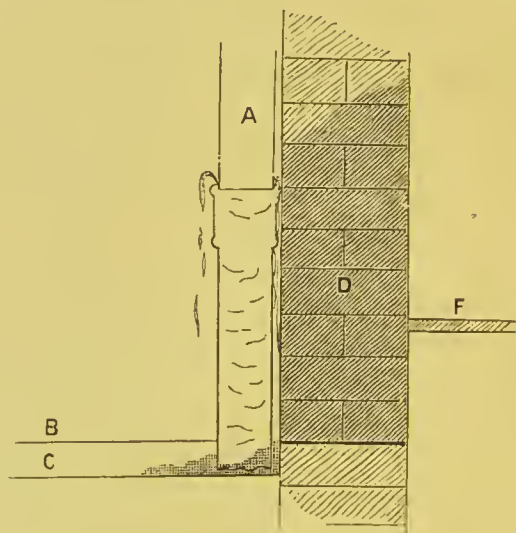
FIG. 2.

Fig. 2 shows the spouting continued by a length which has been broken off too short, and fastened too low. The end being

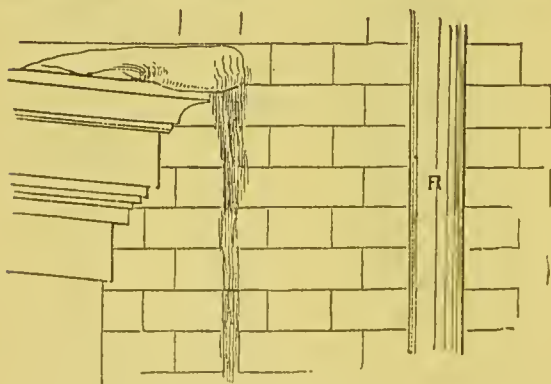
FIG. 3.

Figs. 3 and 4 represent defects lately brought to my notice in a row of new buildings. The bay windows in the front of four small houses have the rain conducted from the roofs, as shown in Fig. 3. In each house a piece of lead, cut too large for the window, is rolled up one side, and conducts the rain on the front wall, where it has already left a large stain. A rain spout R, terminating in a channel in the pavement, passes close by. The bay windows in front of the remaining six houses in the same row have the rain conducted from the roofs as shown in Fig. 4. The lead-covered roof of each window is provided with a short lead pipe, which pierces the coping stone, and delivers, as shown, like a watering pipe.

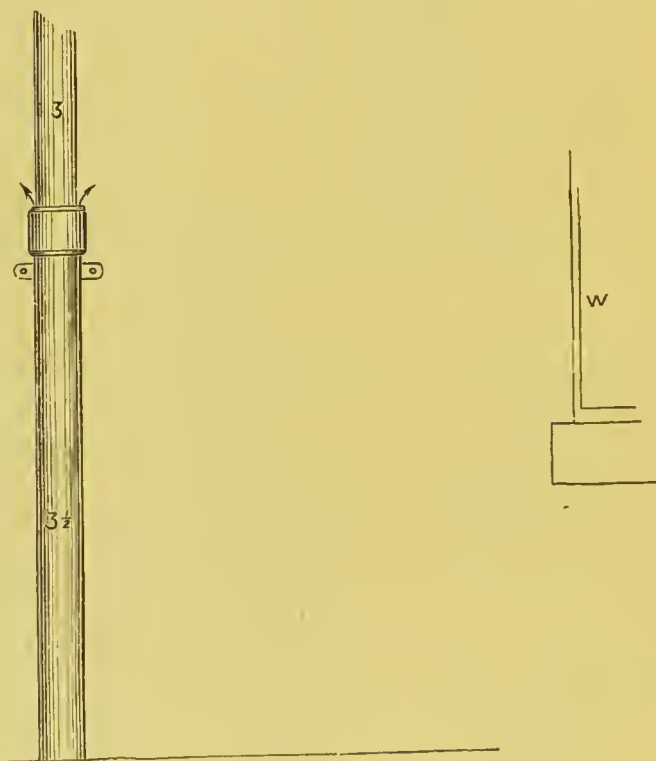
FIG. 8.

Fig. 8 shows an arrangement for conducting rain from an artificer's cottage which I took a note of. The lower length of the rain pipe, which was directly connected with the drain, was $3\frac{1}{2}$ in. in diameter, and the lengths above 3in. in diameter, the joints being unmade. It will be seen that when foul air ascended from the drain, part of it was delivered in front of the cottage, but three feet from a window often open. It seems strange that pipes of different sizes should be used, as in this instance. The explanation suggested is that the petty tradesman employed on the job had not enough pipes of one size, and, to avoid the trouble of sending for what he required, used what he had in stock.

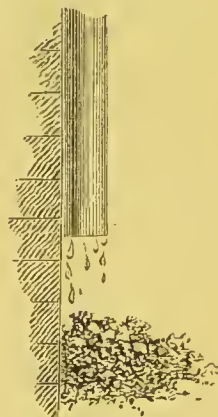
FIG. 11.

Fig. 11 shows a 3in. iron rain spout delivering into an ashpit. The spout receives from the back portion of the roof: thus about half the rainfall is directly conducted into the ashpit. The result is that after wet weather there is an effluvium nuisance from the ashpit, and the contents are usually saturated.

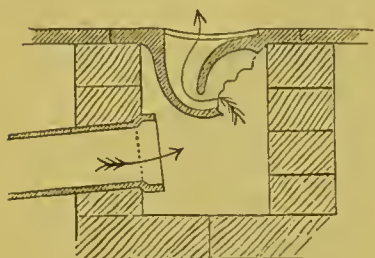
FIG. 17.

Fig. 17 represents the trapping of a yard drain as done by a local tradesman. A notice had been served on the owner of a small cottage dwelling to provide a properly trapped yard drain,

it removed. There was a large hole in the back, as shown in the cut. I questioned the tenant as to whether anyone belonging to the house had removed the trap and broken it, and he said the trap had not been touched since the workmen left. The only course open to me, therefore, was to believe that

a tradesman had been guilty of the fraud of selling and fixing a broken trap.

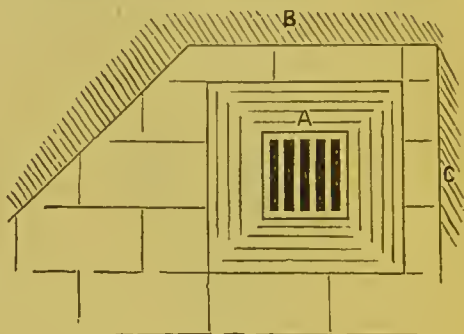
FIG. 18.

Fig. 18 shows a dummy area drain. Damp was complained of in the front wall of a kitchen. The area was paved with brick, and in the corner where the damp was noticed was a

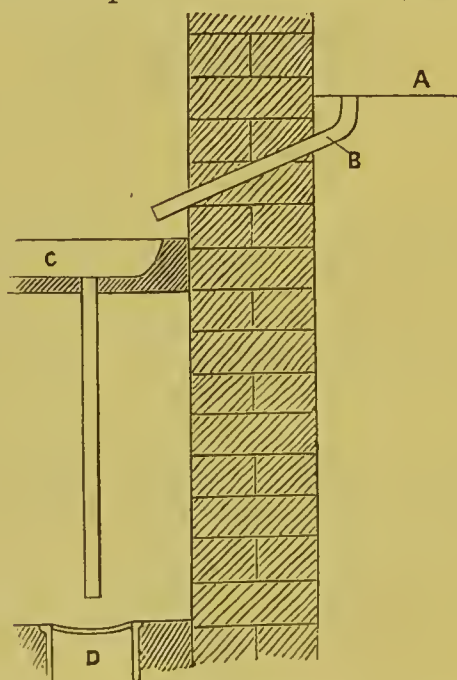
FIG. 19.

Fig. 19 is the section of the wall of a back kitchen. A represents the bottom of an area, C a sink-stone, and D a trap for the back kitchen drain on which the sink waste pipe discharged. Instead of draining this area in a proper way it was drained to the sink-stone by a short lead pipe B. What first led to this part of the house being examined was an effluvium nuisance in the back kitchen, which was traced to the trap D. The trap was obviously sealed with a decomposing animal liquid, and the readiest explanation of this seemed to be that the area had been used after dark for a purpose for which it was certainly not intended.

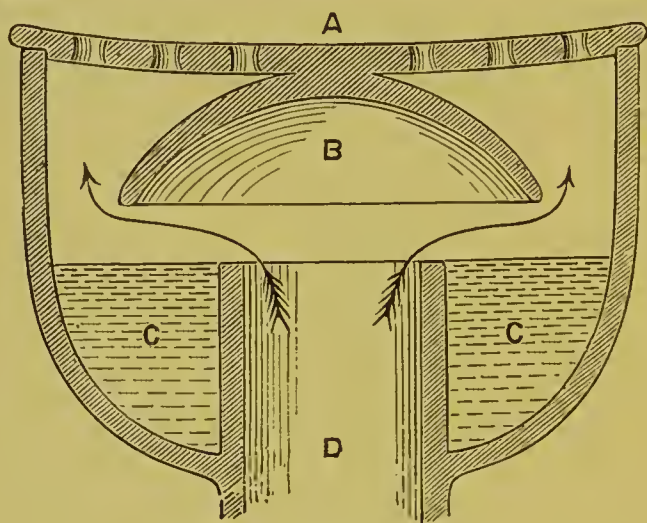
FIG. 20.

Fig. 20 shows a typically bad bell trap I discovered in the scullery of a house rented at £30. I examined it with great care, and then drew the section given, the exact size of the original. A represents the perforated grating, B the bell, CC the water reservoir—which the bottom of the bell never could have reached—and D the portion of the trap which was continuous with the sink waste that went straight into the drain. It will be seen that the whole apparatus is simply a pretence,

the depth of the bell at the centre being barely half an inch, and the distance between the bell rim and the surface of the water being just a quarter of an inch. On the same day, in the same street, I examined a sink bell trap in another house, and found the

depth of the bell at the centre three-eighths of an inch. These were not traps the bells of which had partly corroded away by means of the action of water on iron, but nearly new traps, absolutely useless when fixed.

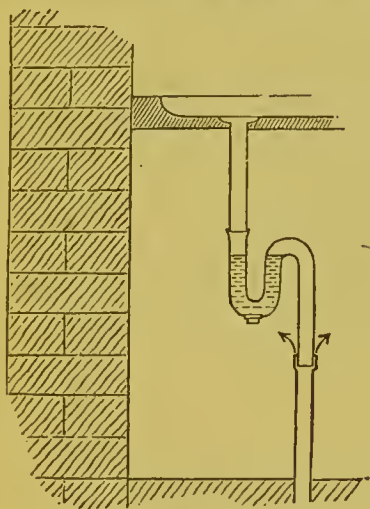
FIG. 21.

Fig. 21 indicates a sink waste pipe and its trap to which my attention was called. Being in a dark corner, it at first appeared to be a satisfactory fixing, but when closely examined it was

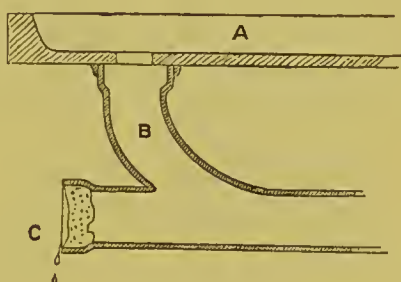
FIG. 22.

Fig. 22 shows a sink in the basement of a house rented at £45. The sink had been fitted with a bell trap, but this was lost. On making an examination beneath the stone it was found

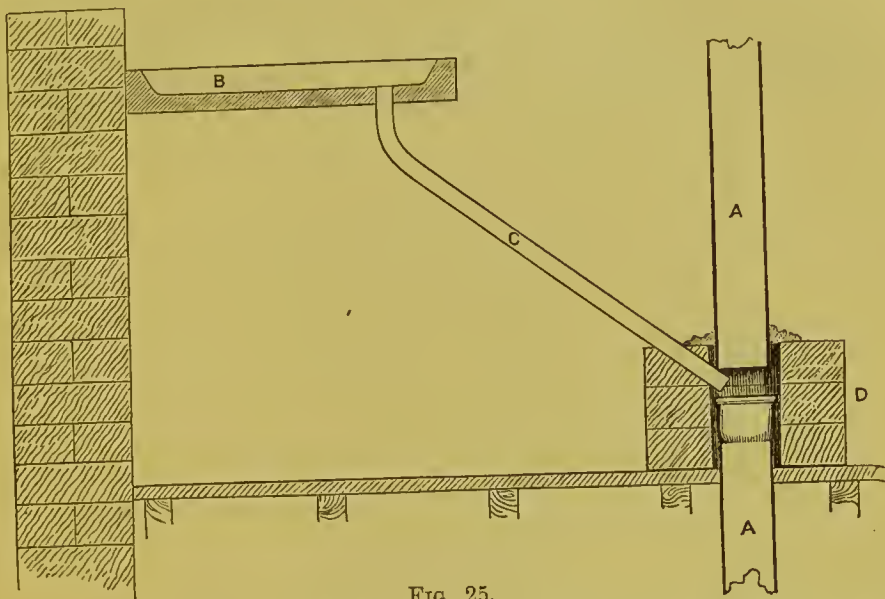
FIG. 25.

Fig. 25 represents an instance of badly-planned and badly-executed work. The defects will be obvious at a glance. A is an iron soil pipe from the closet above, running through the centre of the house to the drain in basement; B is a sink situated on an upstairs landing; and C is the sink waste pipe directly connected with the soil pipe A. It will be seen that the upper length of the soil pipe is not placed well down in the socket of the length of soil pipe below, and properly jointed, but that there

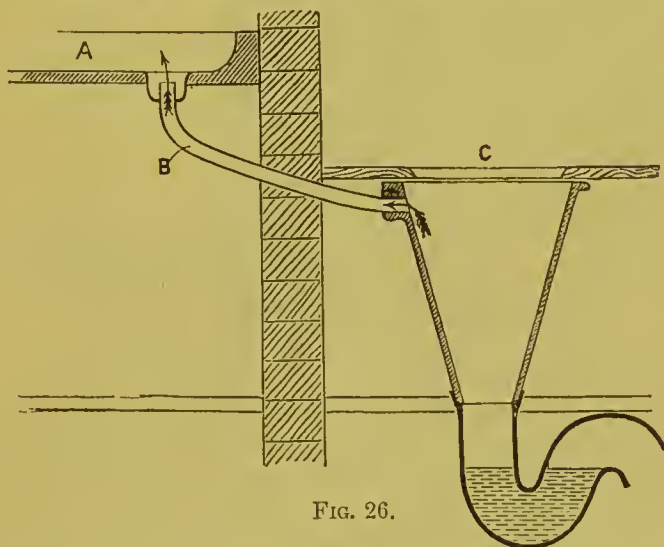
FIG. 26.

Fig. 26 shows an arrangement rather less dangerous to health and life than the one just referred to, but still horribly disgusting. A is a sink-stone, the waste pipe B of which is directly connected to the basin of closet C adjoining. The

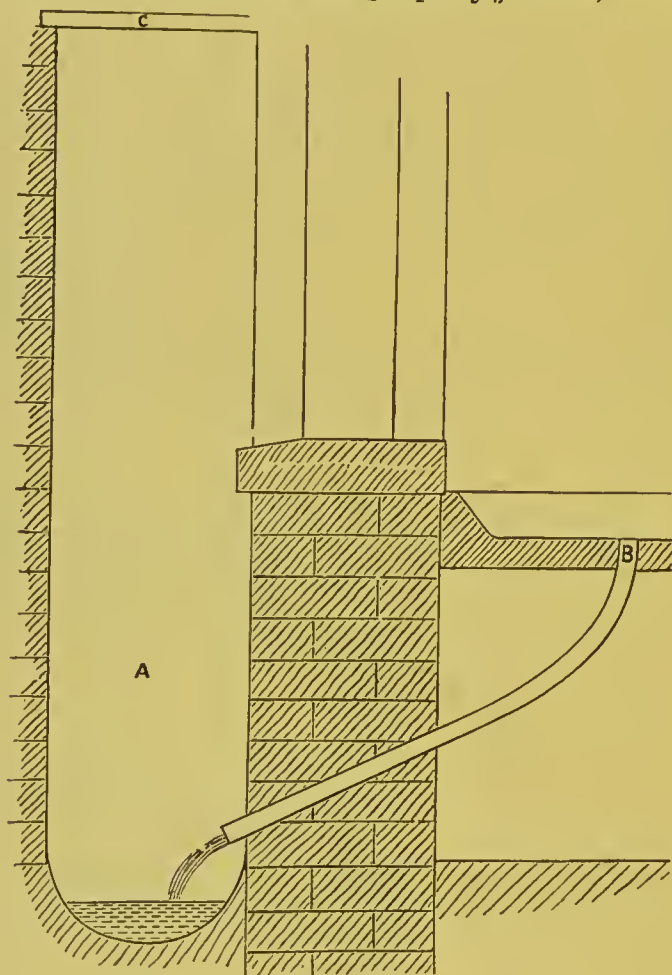
FIG. 27.

Fig. 27 shows a sink in the basement drained into an air drain. The house in which I noticed this defect was a hand-

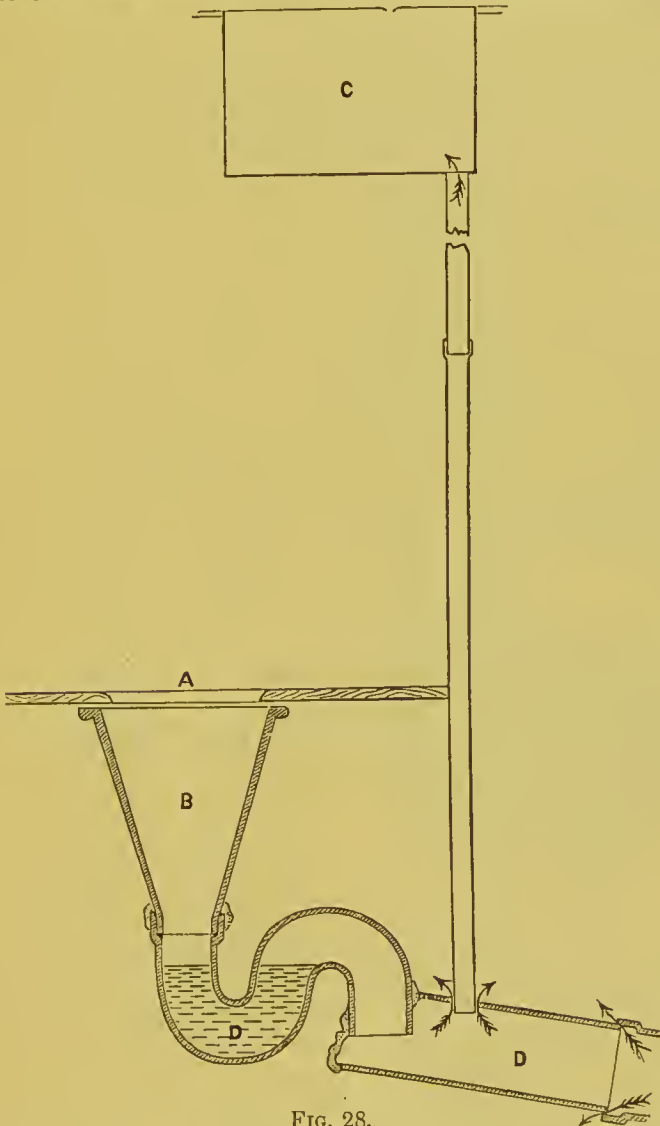
FIG. 28.

Fig. 28 shows what was discovered at a smaller suburban villa rented at £40. There was a complaint of effluvium nuisance, especially in the basement, and the examination of the premises was accordingly begun in the closet in the basement. Here was a basin of the usual pattern, properly connected to a 4in. glazed earthenware trap, and this again was connected to a 6in. glazed earthenware pipe, as indicated in the cut, the joint being not a workmanlike one, but made with cement, and apparently tight. The joint at the other end of the 6in. pipe

was bad all round, and in the upper part of this 6in. pipe a hole had been drilled to receive a 1½in. cast-iron waste pipe. The cast-iron pipe was quite loose, and could be moved freely from side to side. Above was a butler's pantry sink, the lead waste pipe of which was directly connected with the cast-iron pipe. A is the closet seat, B the basin, D and D the trap and drain pipe, and C the sink. The escape of foul air was from the defective joint in the drain, the hole drilled in the drain, and the sink in the butler's pantry.

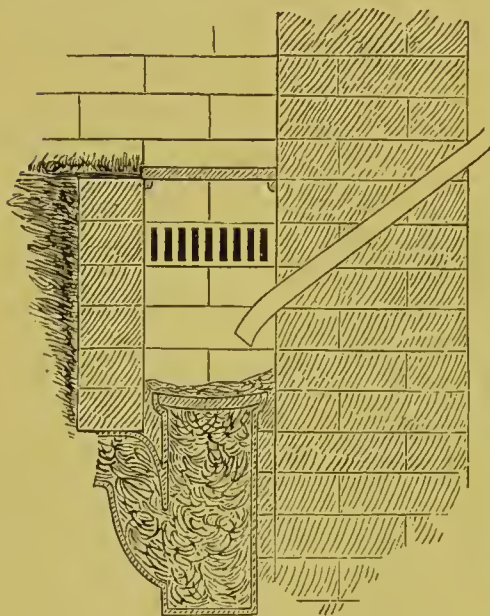
FIG. 29.

Fig. 29 illustrates a curious defect in another villa resi-

dence. Complaint was made that water was coming in through the external wall of a room in the basement used as a washhouse. A plumber was sent for, and it was found that the water came from an iron ventilator in the external wall, which had been put in to ventilate the basement. On the outside of the grating was a small area which had been made to receive the gulley trap on which the sink waste pipe delivered. As this area was covered by an iron grating, no attempt to cleanse it, or the trap it contained, had been made for a long time. The result was that the trap got filled to the brim with fat and other offensive matter; and then the foul water discharged by the sink waste pipe filled the area till it reached the level of the ventilator, and overflowed into the house.

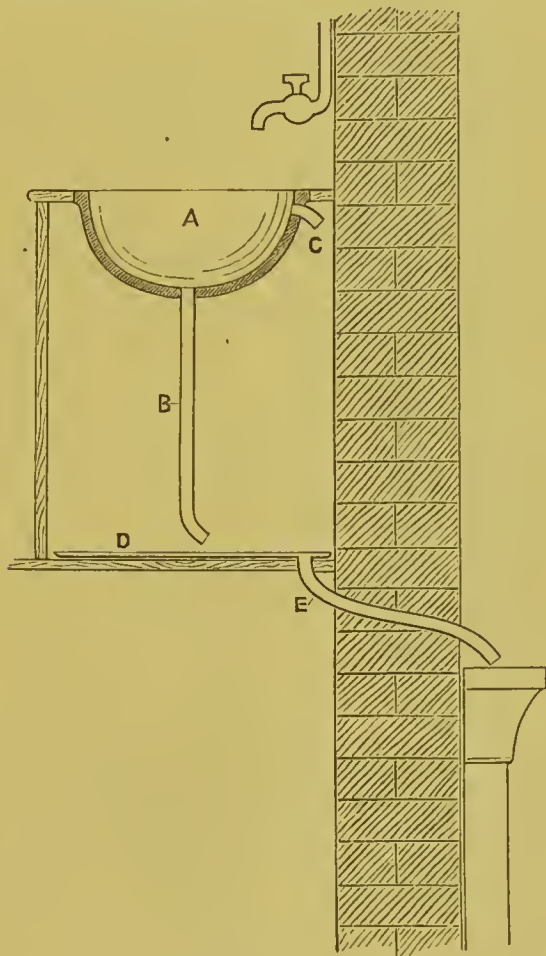
FIG. 30.

Fig 30 has been sent me by a correspondent, who writes me that he recently saw a lavatory basin as shown. It is in his experience a unique way of treating a waste pipe and overflow. The sketch explains itself. A is the basin, B the waste pipe from

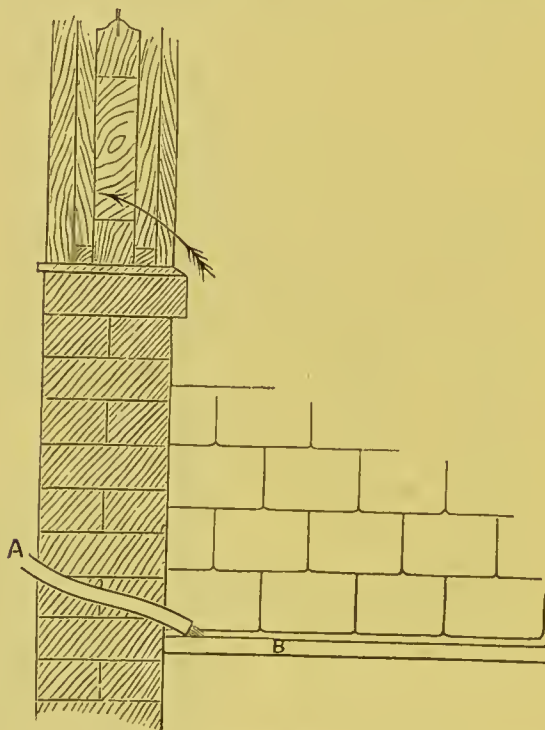
FIG. 31.

Fig. 31 shows a comparatively common defect. It is from a large building used as a hospital. A is a waste pipe from two hand-basins, discharging on a roof gutter B. The foul water from A runs along the open gutter for five feet before it reaches a downspout. Two feet above this gutter, which is ordinarily in a very foul state, is a window. Of course the proper practice

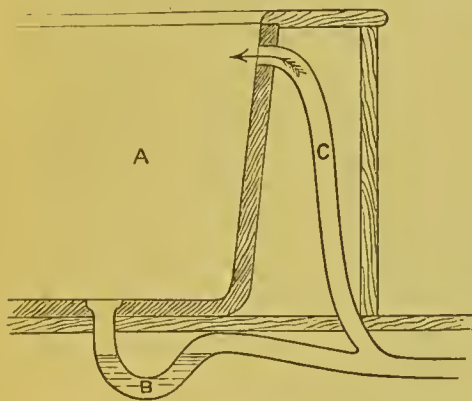
FIG. 32.

Fig. 32 illustrates the danger of an untrapped overflow pipe. A whole family occupying a house in a large town had been suffering from a low type of sore throat. The patient most severely affected had been making use of the bathroom as a bedroom. An examination of the premises, instituted by the medical officer of health, led to the discovery that though the bath waste pipe was trapped, the overflow pipe had been connected to the waste pipe between the trap and the house drain. Thus the overflow ventilated the drain into the bathroom. A is the bath, B the bath waste trap, and C is the overflow pipe.

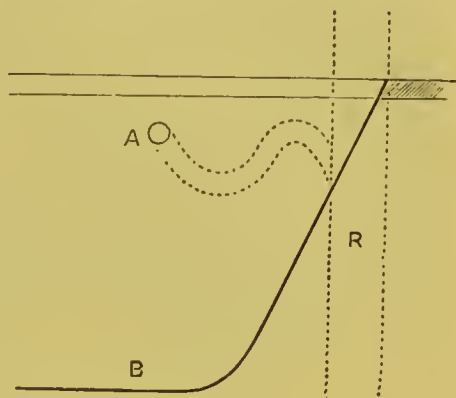
FIG. 33.

Fig. 33 shows in section the upper end of a bath B, situated against an outer wall. There was an overflow pipe at A, taken straight out through the external wall along the outside towards a rain spout R, into which it delivered. Before being connected with the rain spout it was bent downwards and upwards so as to

form a $\cup$ trap. The rain spout was directly connected to the drain, and the $\cup$ trap was empty, so that effluvia and noxious gases from the drains were conducted into the house and delivered close to the face of anyone using the bath. Of course,

when the bath was being used the bathroom would be unusually warm, and abundance of foul air would be drawn up. It is needless to point out that a bath overflow pipe should be disconnected. Twisting the pipe in the form of a $\cup$ trap is of little service, as a bath is rarely filled so full as to bring the overflow into use.

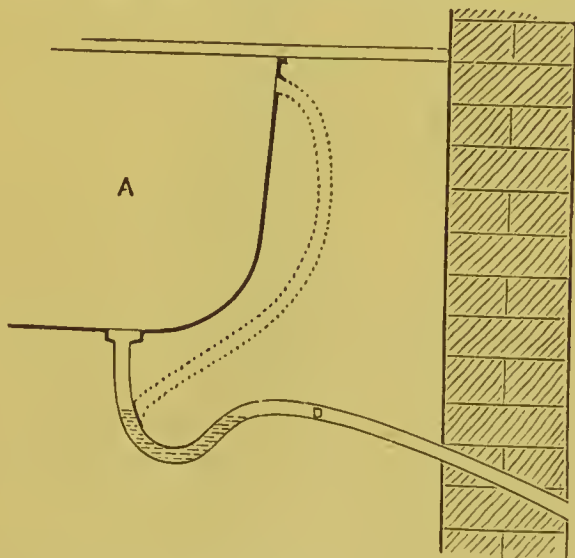
FIG. 34.

Fig. 34 illustrates a familiar defect. In a suburban villa (rent £85), lately built, the bath was found by the tenants to be without an overflow pipe. The bath waste pipe was trapped, and taken out at once, and delivered on a gully trap, and the other sanitary arrangements appeared to be satisfactory. A represents the bath and D the waste pipe, and the dotted lines indicate the position of the overflow pipe which should have been fitted.

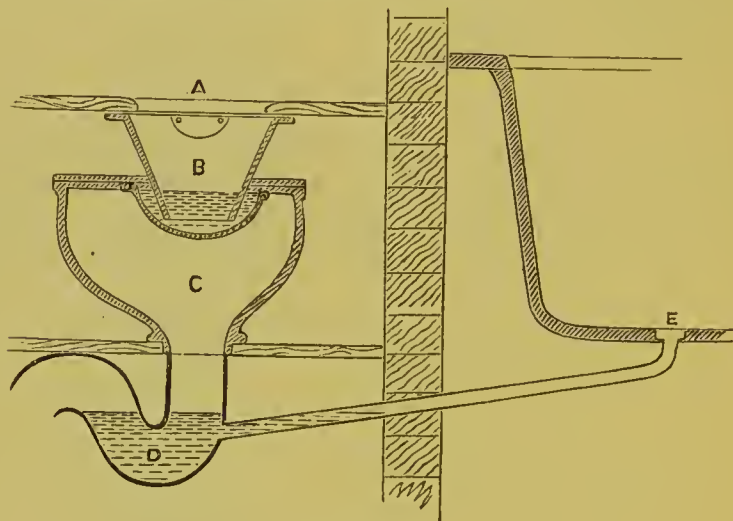
FIG. 35.

Fig. 35 is a section of a closet, showing also a portion of a bath in an adjoining room. As will be seen, the bath waste is taken into the closet trap. There was a complaint of an effluvium from the bath waste, and when the closet was used there were puffs of foul air from the waste pipe. In the cut A is the closet seat, B the basin, C the container, D the trap, and E the pipe wrongly brought into the trap.

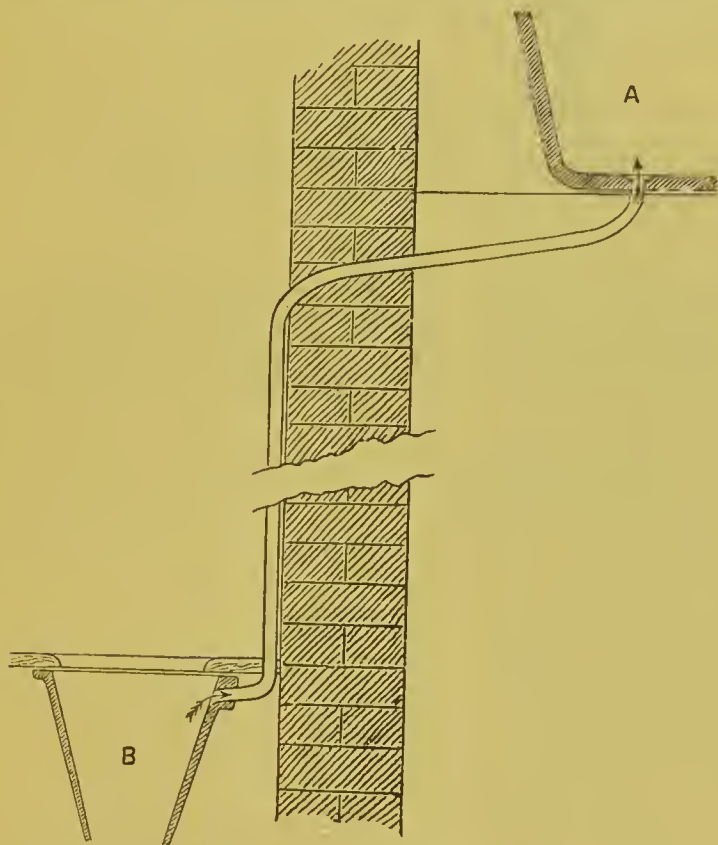
FIG. 36.

Fig. 36 requires little explanation. It represents work carried out by a competent plumber at his own house. A is a bath inside the house and B is the basin of a closet in the yard. These, it will be seen, are directly connected, the waste pipe from the bath being made to flush the closet. There was no other provision for flushing the closet, and as the pipe was untrapped, the foul air from the basin ascended to the bathroom, causing an effluvium nuisance.

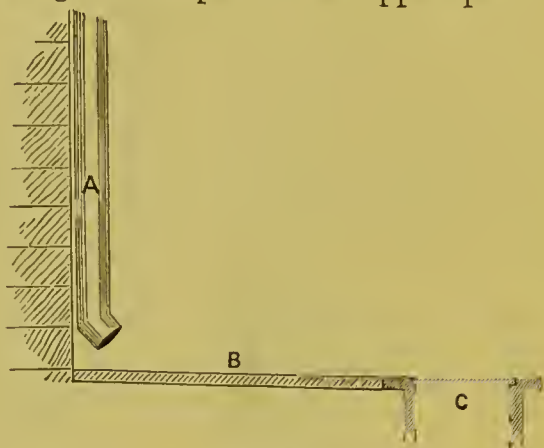
FIG. 37.

The method of delivering waste water represented in Fig. 37 is, I regret to say, not uncommon. The bath and hand-basin waste pipes are brought outside to discharge on the area flags, which are channelled to conduct the water to a trap. Only one waste pipe is represented in the cut, but I have seen three together treated in the same manner. I have also seen the trap a yard or more from the end of the pipe; and sometimes no

channel or conductor to the trap is provided. In any case the result is a nuisance from the foul state of the flagging between the pipe and the trap, and effluvia commonly find their way into the house at the kitchen or pantry window. A is the waste pipe, B the area flagging, and C the trap.

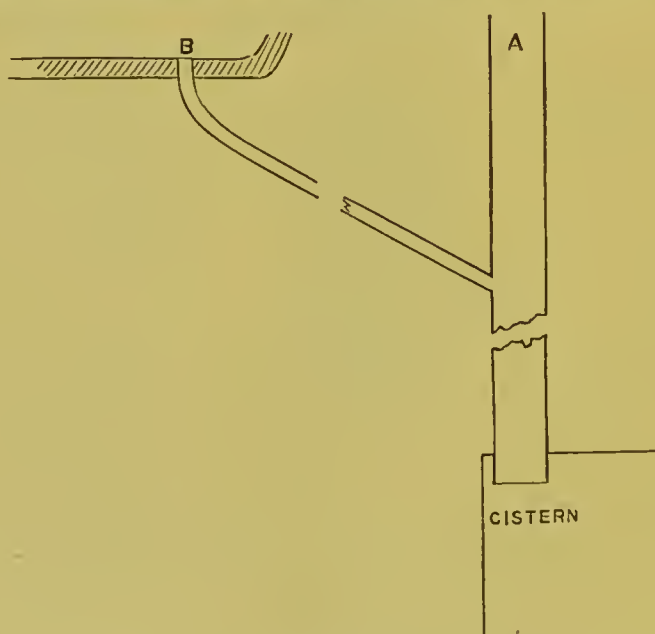
FIG. 38.

Fig. 38 is from a correspondent. He writes: "During my inspection of the sanitary arrangements of an empty house of considerable dimensions, I found that a new bath had been fixed some six or seven months prior to my inspection, and the waste pipe from same connected to a rain-water downpipe, running

close by, for convenience. It seemed to me that the rain-water pipe was in communication with a tank under the house, some distance away, and accordingly I gave instructions for opening the tank, with the result I anticipated. The bath had been in use for three or four months before the house was vacated." In the figure B is the bath and A the rain pipe.

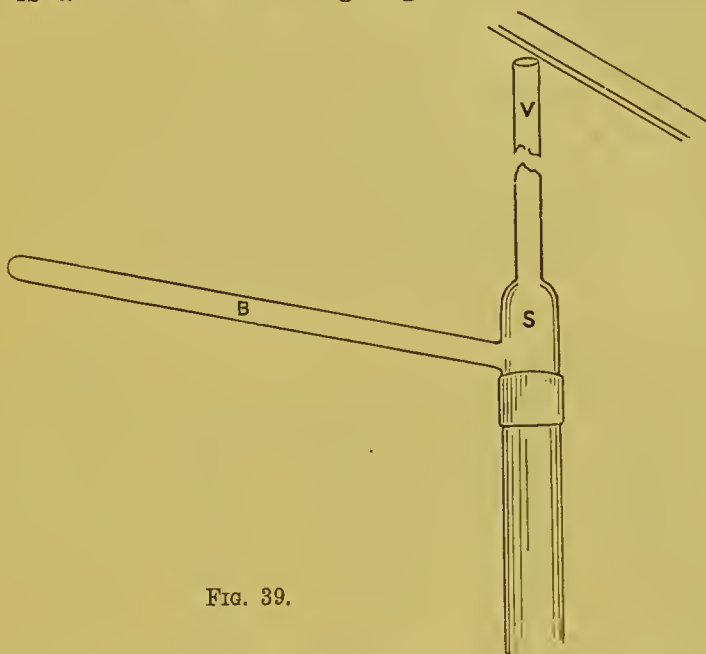
FIG. 39.

Fig. 39 represents a soil pipe and bath waste pipe, as seen from the outside, in a villa residence I lately examined. S is

the 4in. lead soil pipe jointed to an iron one; V is a 2in. ventilator, terminating just under the projecting edge of the roof; and B is a 2in. bath waste going direct to the soil pipe. Of

course, the bath waste pipe acted as a supplemental ventilator, ventilating the soil pipe into the bathroom.

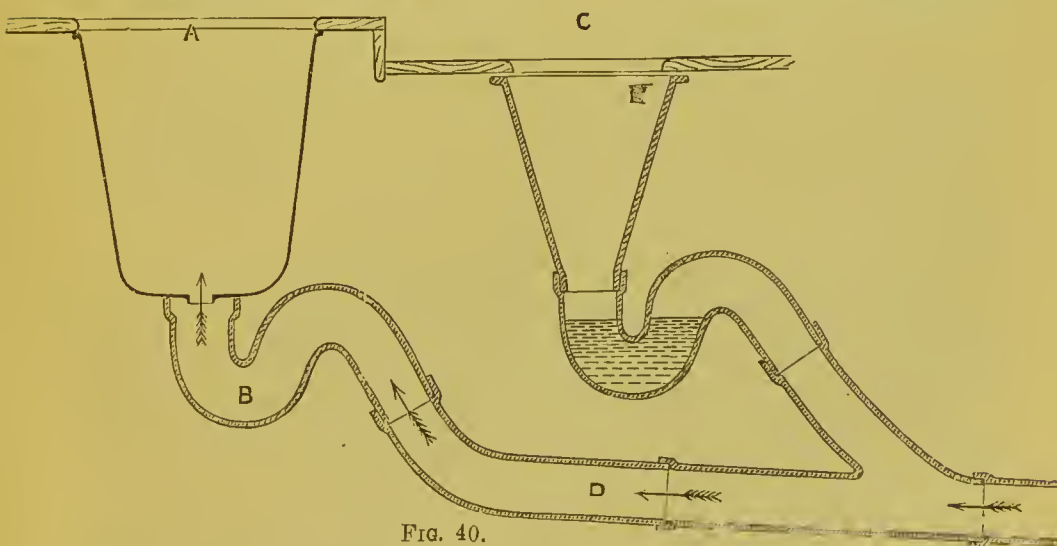
FIG. 40.

Fig. 40 shows in section a bath and closet situated in a small outbuilding erected as a "lean-to" in the rear of a dwelling-

designed for the hot and cold supply twisted and immovable. The tenant said the bath had never been used. Of course, the 4in. earthenware pipe trap beneath was dry; and although the closet trap was acting, there was nothing to prevent the drain gases and effluvia having access to the room. A represents the bath, B the trap to the same, C the closet, and D the drain. In designing the house it was a mistake to put the bath in an outhouse, access to which could only be obtained by crossing a yard. Such a bath would almost certainly be neglected. However, it would have been quite easy to have made the bath waste deliver on the gully in the yard, and then, whether the bath were used or not, no nuisance could have arisen.

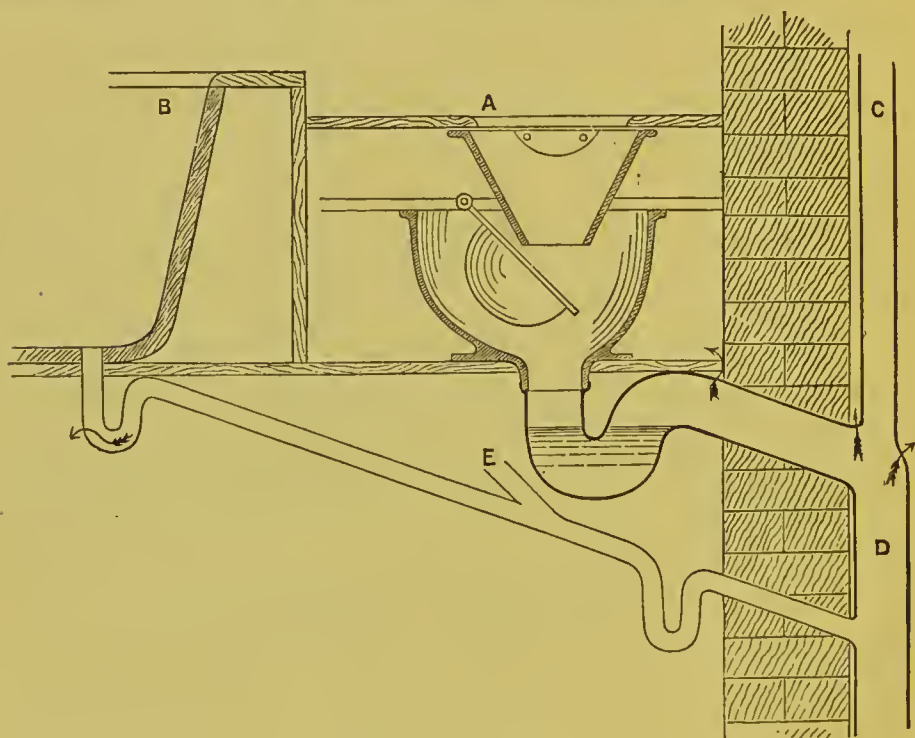
FIG. 41.

Fig. 41 shows the cause of an effluvia nuisance, which was most manifest near the bath. It was found that the trap under the bath was leaky, and an ineffectual attempt had been made to repair it with canvas, while the trap on the bath waste, next the wall, appeared to have been syphoned. A is the closet, B the bath, D a 4in. soil pipe, C is a 2½in. rain spout, made to act as a ventilator for the soil pipe, and E is a waste pipe from a urinal. As there was no trap between the sewer and the soil pipe, and the connections of the closet trap and soil pipe, and rain spout and soil pipe, were imperfect, sewer gas could escape into the bath and urinal, and at the points indicated by the

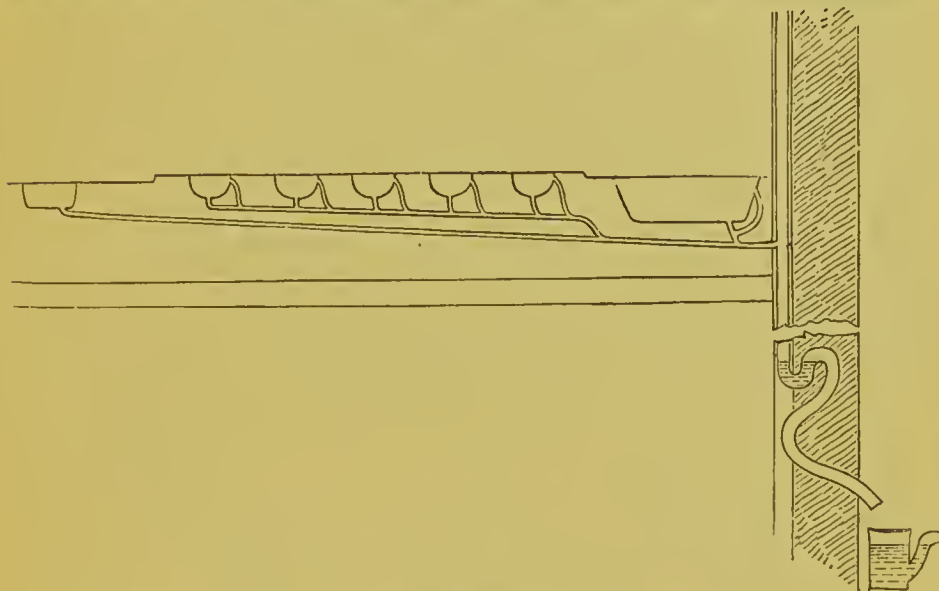
FIG. 42.

Fig. 42 represents a housemaid's sink, row of hand basins, and a bath, with waste pipes and overflow pipes discharging

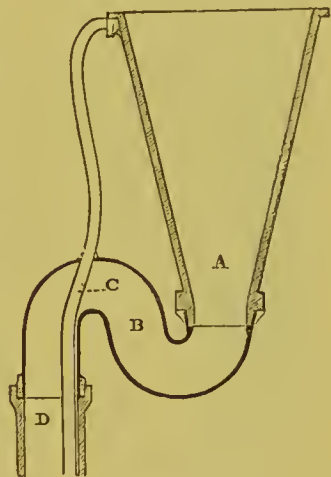
FIG. 43.

Fig. 43 shows the arrangement. A represents the basin, B the lead trap, C the lead service pipe, and D the earthenware soil pipe. Where the service pipe came through the trap it was carefully soldered round, but where it entered the earthenware soil pipe, about 14ft. lower down, the stopping was of mortar, and imperfect, allowing the passage of foul air from the soil pipe into the basement. Thus was the nuisance caused which led to this extraordinary service being brought under the attention of the sanitary authority. The closet and soil pipe, which were against the party wall, 13ft. back from the front of the house, were removed, and the nuisance has therefore been effectually abated. I find the terrace in which this house is situated was built in 1871, and each house has a watercloset against an external wall, and fitted with a separate service cistern. A previous tenant of the house complained of had a bedridden relation, for whom he desired to provide a closet in the upper storey, and employed a local plumber with the results shown.

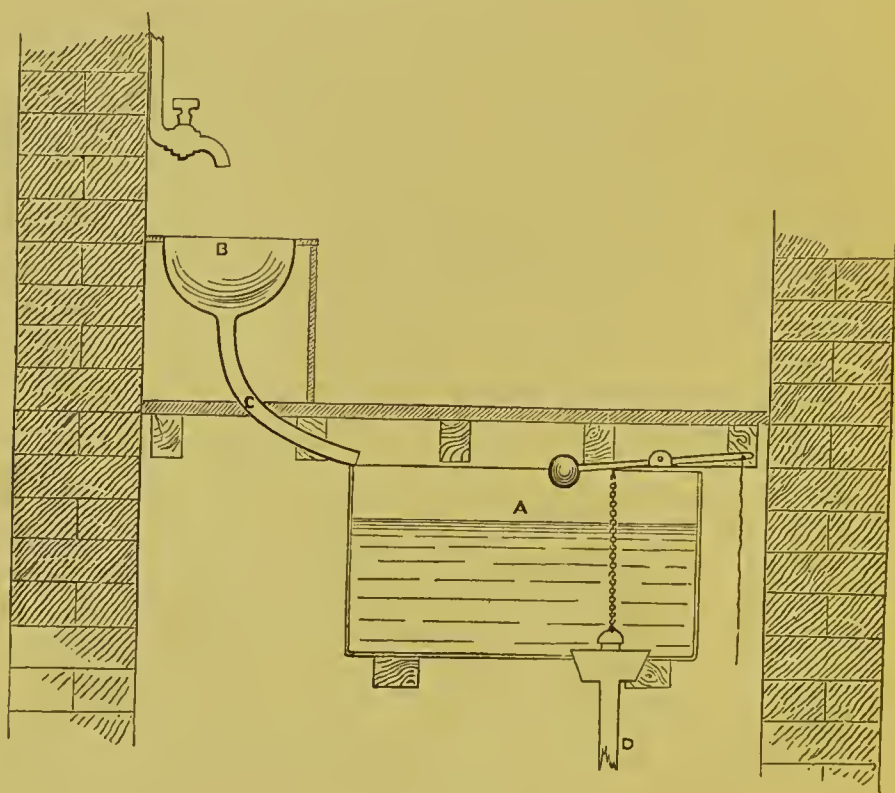
FIG. 44.

a villa residence he inspected. It seems strange how a plan so obviously objectionable came to be adopted. The sketch is reproduced in Fig. 44. A is a cistern serving the closet beneath, the cistern being supplied with rain water through a pipe not shown. B is a housemaid's sink, and C the waste pipe from the same, discharging into the cistern A. D is the pipe flushing the closet. An effluvium nuisance having arisen each time the closet was flushed, the apparatus was carefully examined, and it was then discovered that the closet was flushed, not with rain water only, as was supposed, but also with the slops daily thrown down the housemaid's sink.

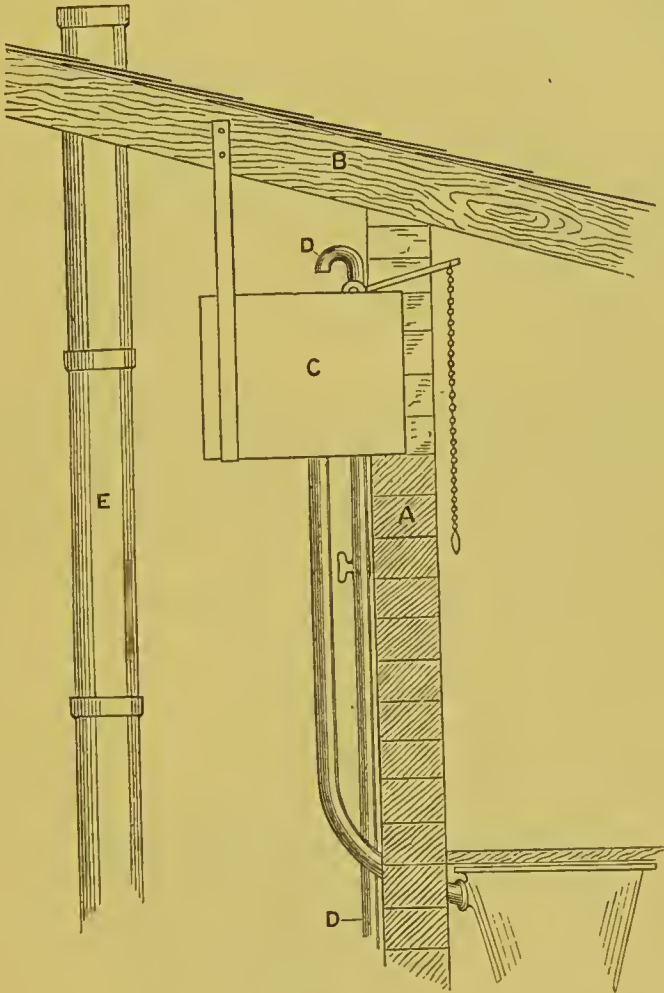
FIG. 45.

Fig. 45 shows how some midden privies were converted into dry ashpits and waterclosets. A hole was made in the wall A, just under the rafters B, large enough to admit the end of the cistern C. The cistern in each case was of light galvanised iron, 15in. by 6in., and 12in. deep. The whole of the cistern, excepting the small portion resting on the wall, is actually in the ashpit. Cisterns in such a situation are exceptionally liable to get foul, and are almost inaccessible. No overflow is provided, and the supply pipe D passes up a corner of the midden, through the ashes and refuse. The drain from the closet is ventilated (or, to be more correct, an exit for the drain air is provided) by means

of 4in. earthenware pipes E, built up the end wall of the middenstead, and delivering effluvia at a low level.

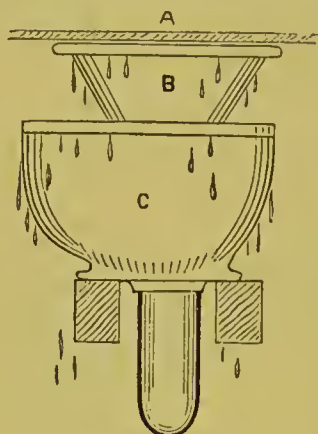
FIG. 46.

Fig. 46 represents an old pan closet as seen from the front. It was the only closet in a suburban villa rented at about £40. A nuisance was complained of, and on removing the wood which concealed the basin and container, both were found to be in a most filthy state, as well as the parts beneath. There was no

housemaid's sink on the premises, and it was obvious that when the housemaid had thrown the slops into the basin they had frequently run over. As no lead tray, ordinarily called a "safe," was provided, the slops running over saturated the woodwork all round, the result being a most abominable nuisance. It is noticeable that the sanitary fittings of this house had been in other respects well planned. The rooms were specially ventilated—the waste pipes, overflow pipes, and rain spouts were discon-

nected, &c.—but as unfortunately the local byelaws do not require safes to be placed beneath closets, a *saving* had been effected in this respect. This is not the only nuisance I have found due to this cause, but certainly the worst. In the cut, A is the seat, B the basin, and C the container.

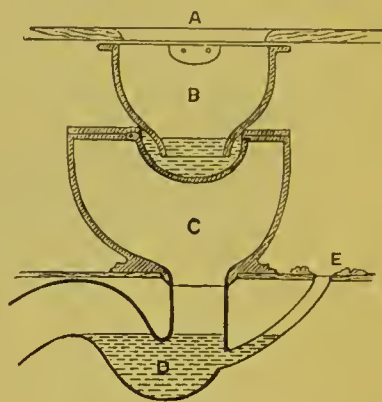
FIG. 47.

Fig. 47 shows a closet in which the lead tray just referred to was provided, but a nuisance had been caused through draining the tray into the closet trap. The surface of the safe around the drain was filthy, showing that foul matter had been pumped up from the trap each time the closet had been used. A is the

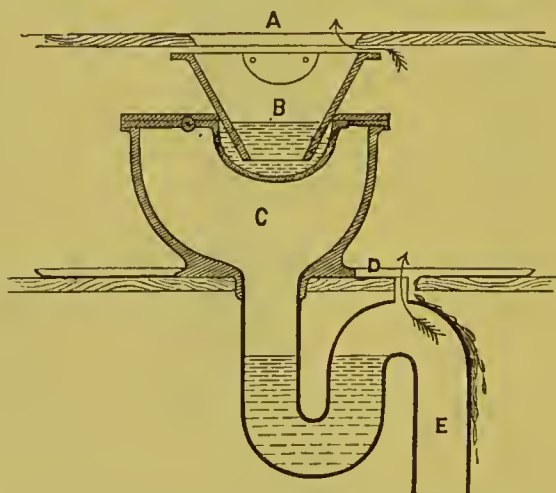
FIG. 48.

Fig. 48 represents a much more serious blunder on the part of a local plumber. The safe or tray to catch any foul water, &c., overflowing from the basin had been fixed, but in order to drain it a lin. pipe from the safe had been carried into the soil pipe. The

soldering of the top of this short pipe to the safe had given way, and it was found that the safe had been draining on the outside of the soil pipe. However, the foul air and gases in the soil pipe had ready access to the house, as shown by the arrows in the illustration. A is the closet seat, B the basin, C the container, D the safe, and E the soil pipe. The house in this instance was a very old one (rent about £40), and the closet fittings were old and worn.

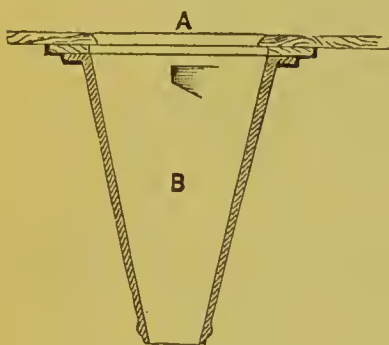
FIG. 49.

Fig. 49 shows in section a curious fixture, which, I think, cannot be very common. I can only describe it as a privy got up to look like a watercloset. A long earthenware basin B was screwed up to the underpart of the seat A, and the surface of the earthenware had become exceedingly foul. The quaint name was given it—"a dry watercloset."

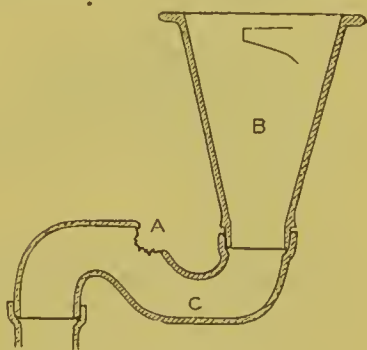
FIG. 50.

Fig. 50 represents a watercloset without water service, which was fitted in the yard of a cottage situated in a back court. On seeing there was no arrangement for flushing, I was surprised

the basin was not full, and I directed a further inspection, when it was found that a hole had been made in the top of the earthenware trap, which was jointed to the basin. I made particular inquiries as to this hole, and was told that "the man that fettled the thing, for fear it would get choked," made the hole—in other words, the hole was made that the contents of the pipe beyond might be pushed on with a stick, or otherwise. In the woodcut, B is the basin, C the earthenware trap, and A the hole referred to. As the hole was made on the drain side of the trap, it established a direct communication between the drain and the closet, which would have remained even if the trap had been kept charged with water.

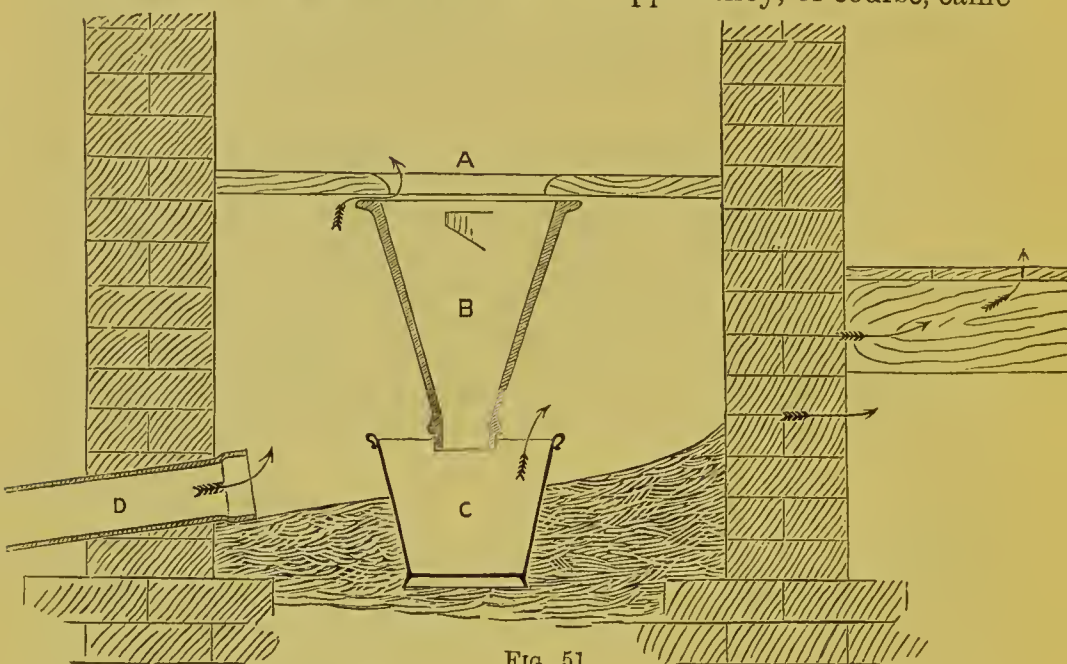
FIG. 51.

Fig. 51, sent me by a correspondent, represents a closet basin trapped into a galvanised iron bucket. The contents, of course, overflowed and found their way into the open drain shown to the left in the sketch. Next to this abominable closet was the kitchen, and the foul air and foul smells went through the joints

of a wall, almost destitute of mortar, and between the planks of the floor into the kitchen. The man who fitted this closet seems to have aimed at preventing the sewer gases from coming up the basin; but as the drain was untrapped they, of course, came

up without check external to the basin. The result of his contrivance was that he produced even a worse nuisance than if he had simply jointed the untrapped drain to the basin. A is the seat, B the basin, C the bucket, and D the drain.

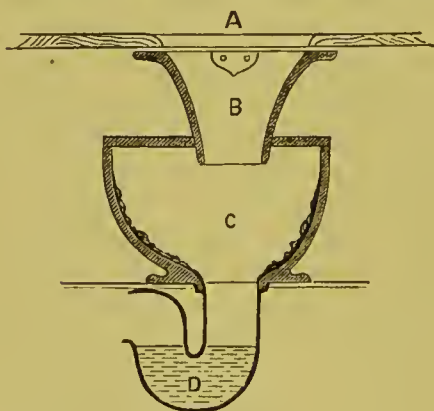
FIG. 52.

Fig. 52 shows an ordinary "pan" closet, which was fixed without a pan. The tenant had been in the house upwards of

a year, and told me the closet was as I found it from the first. If the pan had merely become broken off at the hinge it would have fallen, and probably caused an obstruction; if from any defect in the apparatus the pan could not recover its proper

position after flushing, it would have been hanging empty in the container. As it was, it was simply missing, and the plumber must have fixed the apparatus as I found it. The whole of the inner surface of the container, which was, of course, foul, was exposed, and a cause of more or less effluvium nuisance. A is the seat, B the basin, C the container, and D the trap.

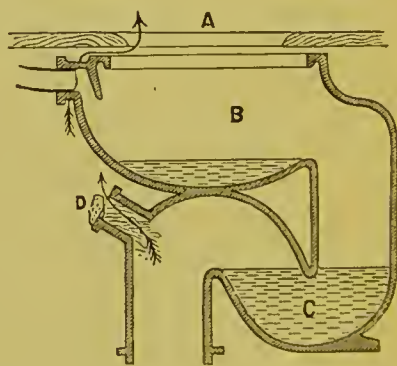
FIG. 53.

Fig. 53 indicates a danger from certain new forms of closets which had not occurred to me till the defect shown in the cut. came under my attention. Many of these closets have an opening placed behind the trap for connecting a ventilator. The "National," the closet shown in section in the illustration, is thus contrived. It appears to be a good closet, and, if properly fixed and kept clean, is free from nuisance. However, very great nuisance was experienced from the particular closet I refer to, and, on uncovering it, it was found that the man who fixed the apparatus, instead of attaching a ventilator, filled up the hole where the ventilator should have been connected with *paper*, and covered this over at the top with putty. In course of time the putty loosened, and then the foul air from the soil pipe had ready access into the house. Of course, this foul air was rendered more foul by passing through a plug of paper saturated with the filth of years. A is the seat, B the basin, C the trap, and D the "stopped" vent hole.

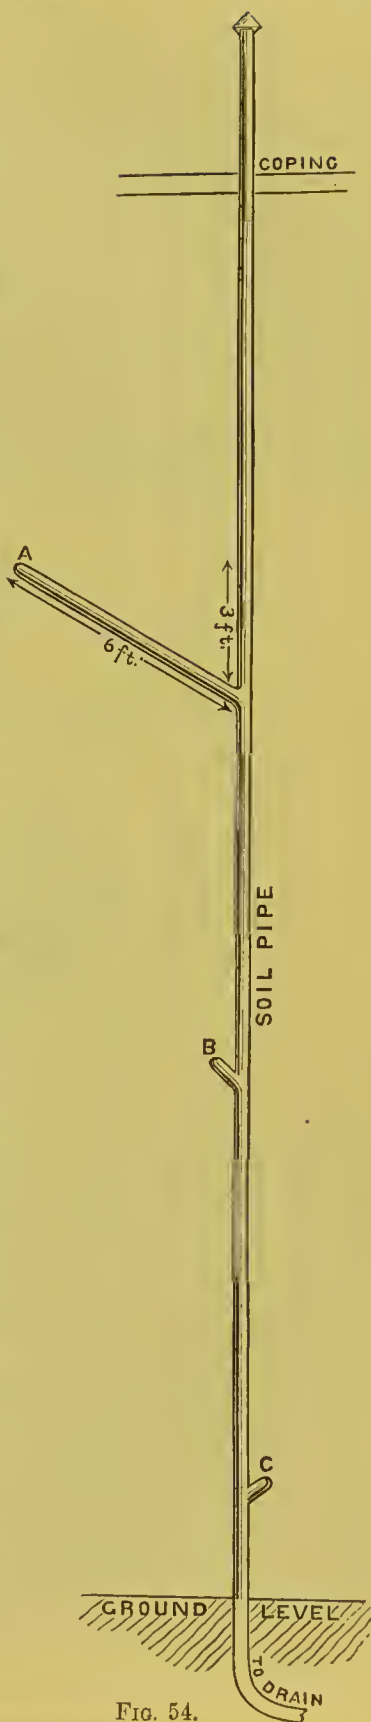
FIG. 54.

Fig. 54, with a description of the defect represented therein, was sent me by a correspondent. Complaint was received from a large boarding school, and my correspondent made a careful examination of the sanitary arrangements generally. On applying the smoke test it was found that smoke issued from the basin of the

watercloset at the top of the house, owing to the seal of the trap of this watercloset having been broken. How this had happened was not easy to discover. The trap was filled, and then the closet was flushed in the usual way. It was a powerful flush, but the water seal of the trap was only reduced from $1\frac{3}{4}$ in. to $1\frac{1}{2}$ in. Further inquiry, however, elicited the fact that the house slops (including water from sponge baths, &c.), amounting to about twelve pailfuls, were every morning emptied down the closet referred to, one pailful after another in quick succession. By way of experiment a pail of water was discharged into the basin of the closet quickly, and the normal depth of water in the trap was found to be reduced three-quarters of an inch. Another pail was discharged in like manner, and the depth of water in the trap was reduced half an inch more. A

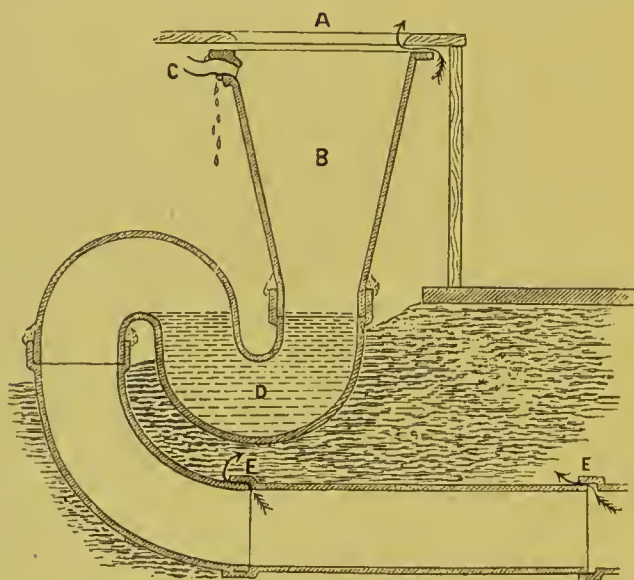
FIG. 55.

Fig. 55 shows in section a closet in the basement of a large semi-detached house in the suburbs. The closet was situated
